UNITED STATES ENVIRONMENTAL PROTECTION AGENCY

Re: Notice of Violation  
RCRA Compliance Evaluation Inspection  
Multicircuits Inc.  
EPA I.D. No.: WID988580072

**Attachment A**  
**Photographs for Multicircuits RCRA CEI**  
**WID 988 580 072**  
**February 12, 2013**

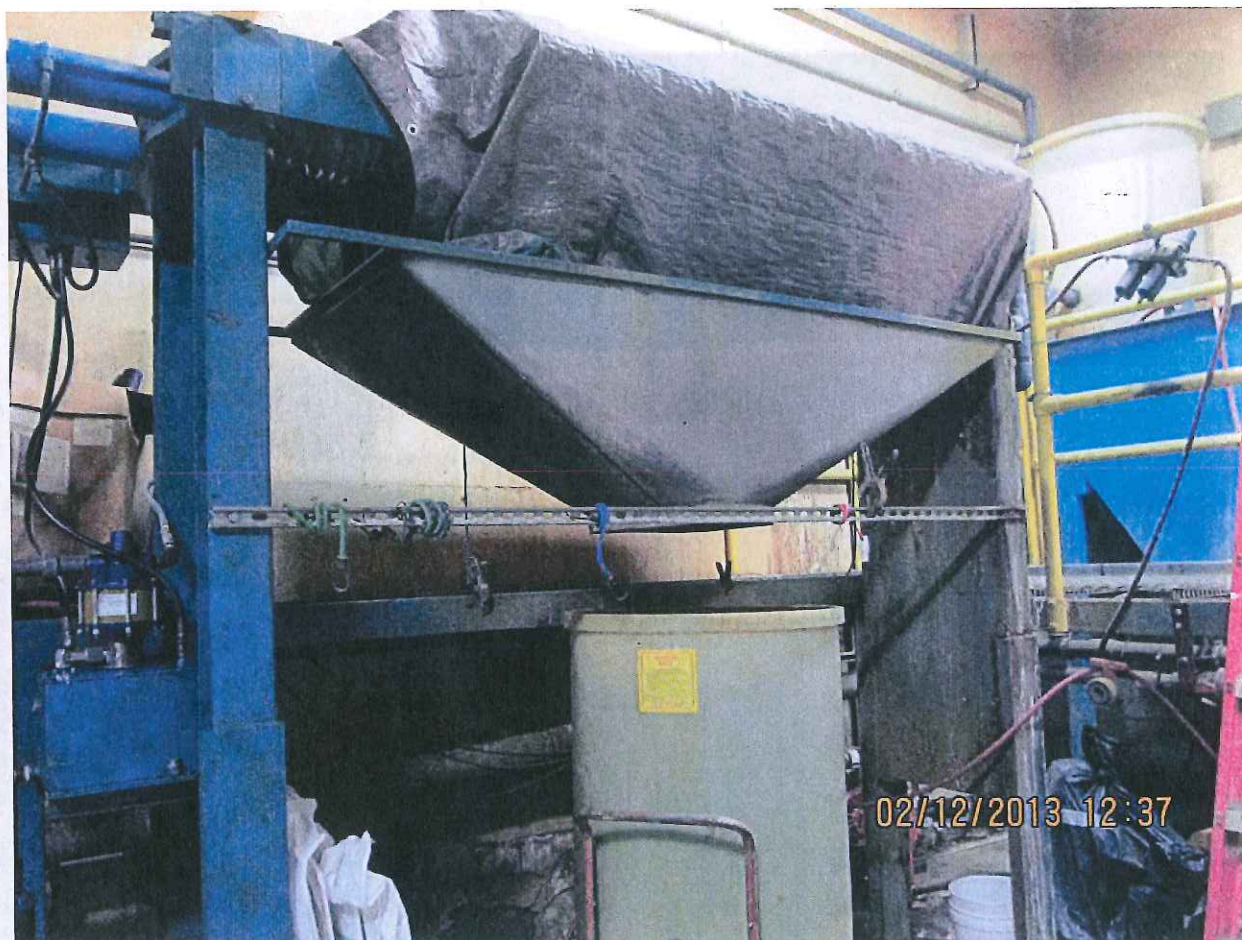
Photograph: #29

After observing the 90-Day Accumulation Area, the inspection proceeded to the Wastewater Treatment Area. The wastewater treatment unit container was labeled as F006 hazardous waste. Inspector Dabner did not observe any F006 hazardous waste in the wastewater treatment unit container. A picture was taken of the marked 55-gallon drum container with no waste. See

Photographs# 29-31. Inspector Dabner did not observe a lid for the hazardous waste container during the inspection.

Description: Waste water treatment unit with a container marked with hazardous waste label; no hazardous was observed in the contained at the time of the inspection

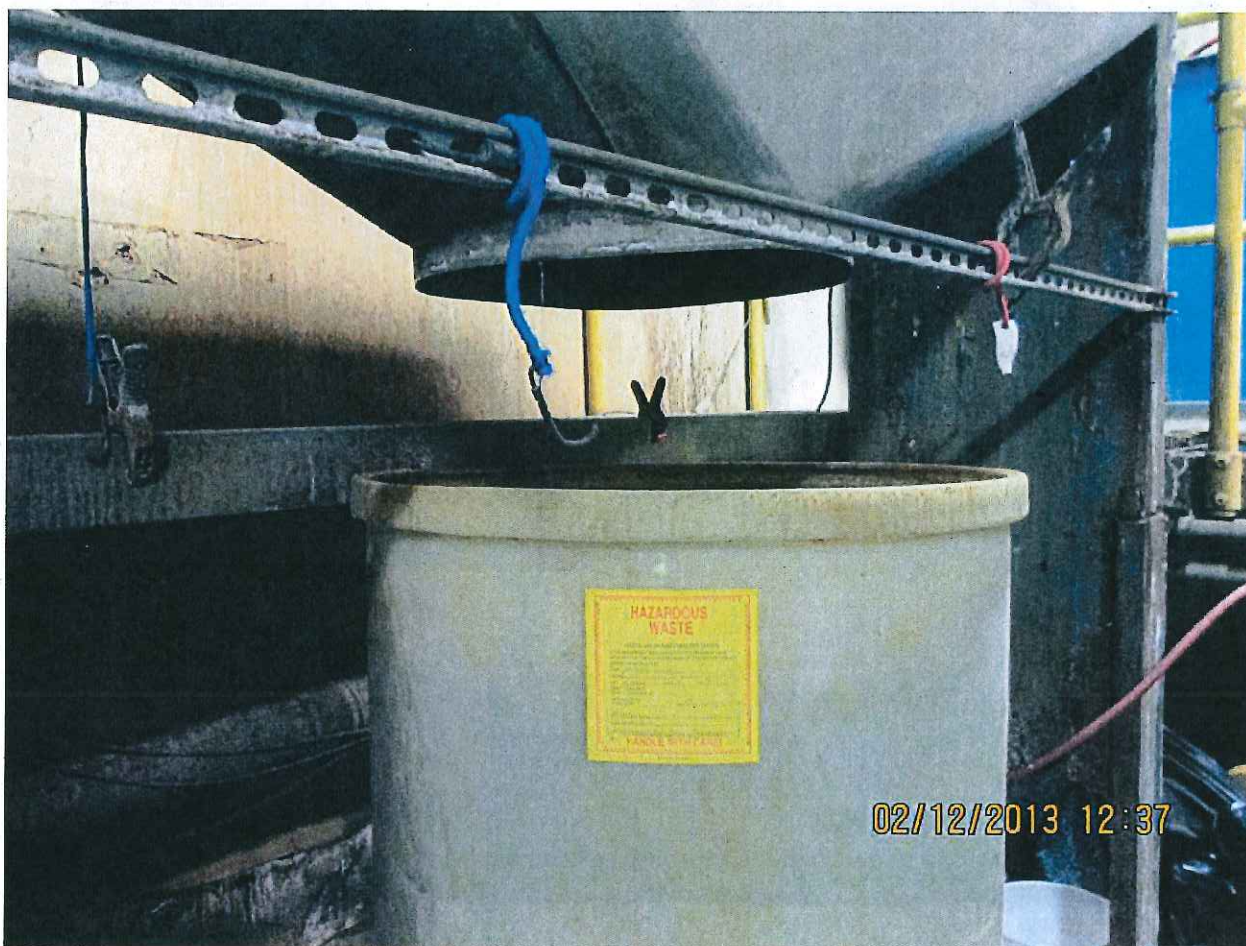
Photograph: #30

Description: A closer picture of the waste water treatment unit and the container marked with hazardous waste indentified in Photo#29

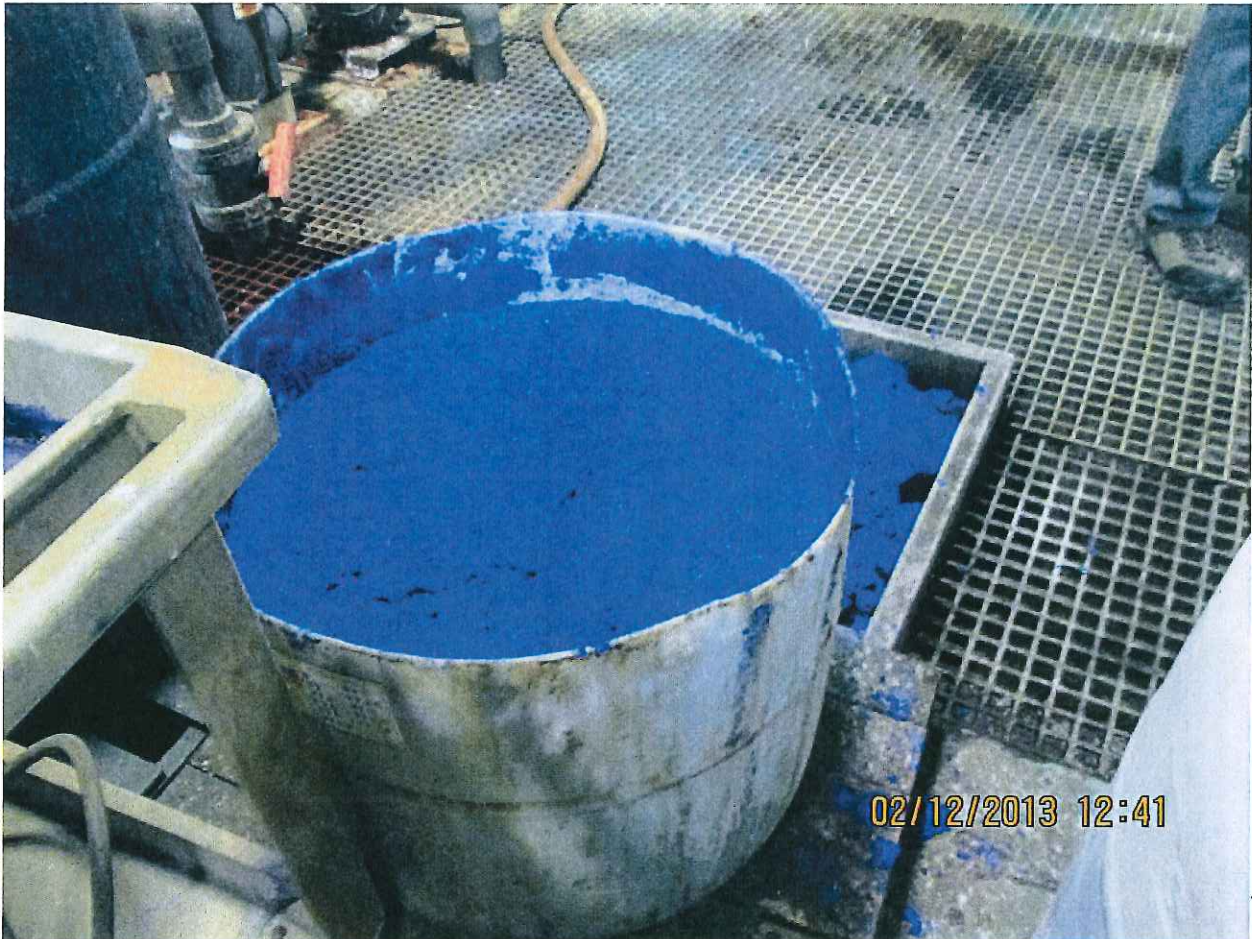
Photograph: #32

Inspectors observed an uncovered 25-gallon container storing blue substance (Riston). According to Mr. Kemper, the blue substance is considered to be non-hazardous photo resistance dry fill based on process knowledge. No documentation support the nonhazardous waste determination was provided at the time of the inspection. A picture was taken of the 25-gallon container. See Photograph#32.

Description: Unmarked 25 gallon container containing organic photo resistant dry-fill chips located in the Wastewater Treatment Unit

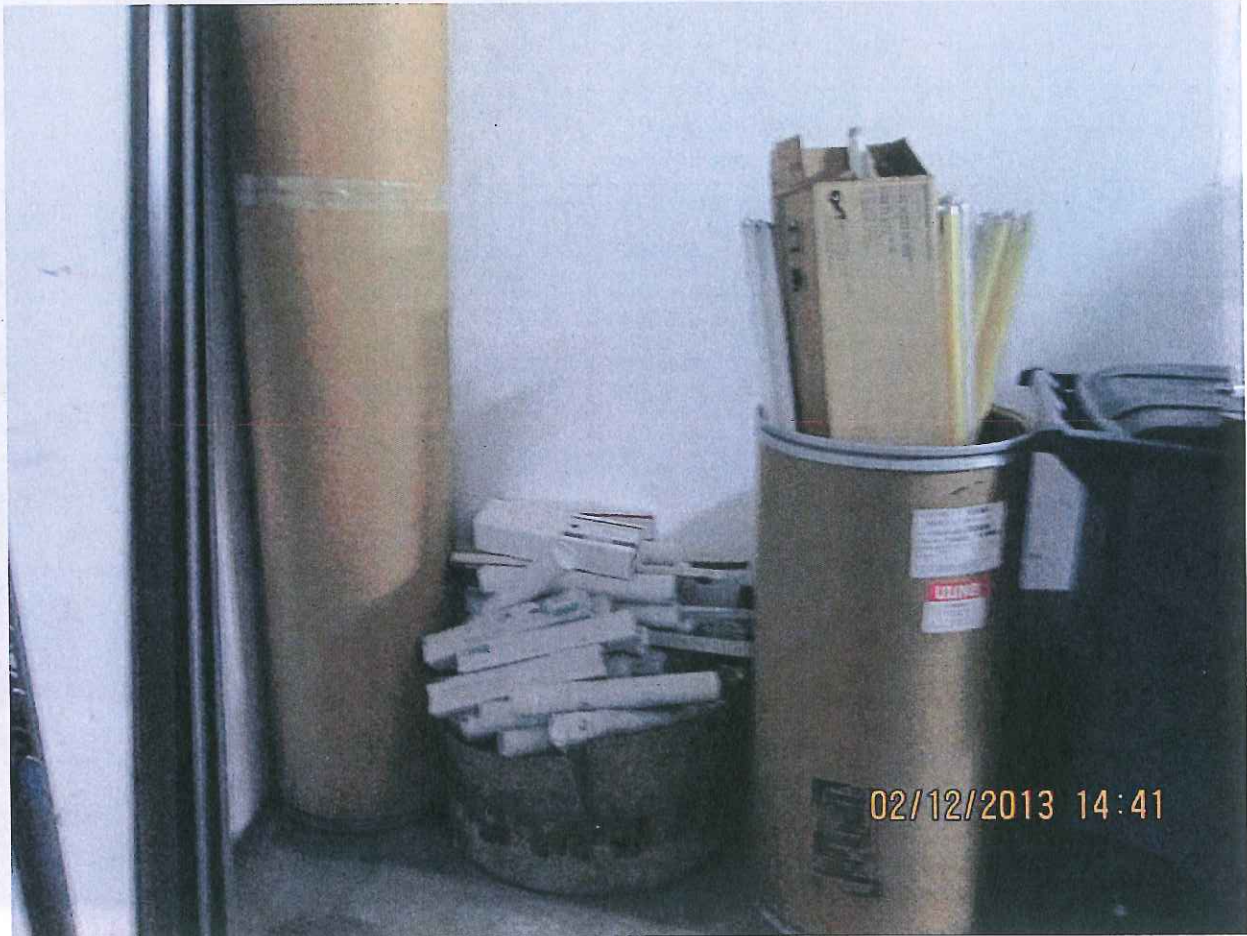
Photograph: #33

During the inspection of the Universal Waste Accumulation Area, the inspector observed lamps stored in a container that was not properly labeled and marked as universal waste. Multicircuits, therefore, violated the above-referenced universal waste requirements. However, Multicircuits, submitted documentation on April 8, 2013 showing the proper labeling and marking of the container storing the lamps. Thus, no further actions are necessary to comply with the above-reference condition/requirement.

The inspectors toured the Universal Waste Accumulation Area. A picture was taken of the Universal Waste Accumulation Area. See Photographs#33-34. Inspector Dabner observed universal waste containers not labeled and marked with the specific waste stored in the containers. The inspectors could not determine the accumulation dates for lamps and batteries stored in the universal waste area.

Description: Container not marked with the specific type of Universal Waste

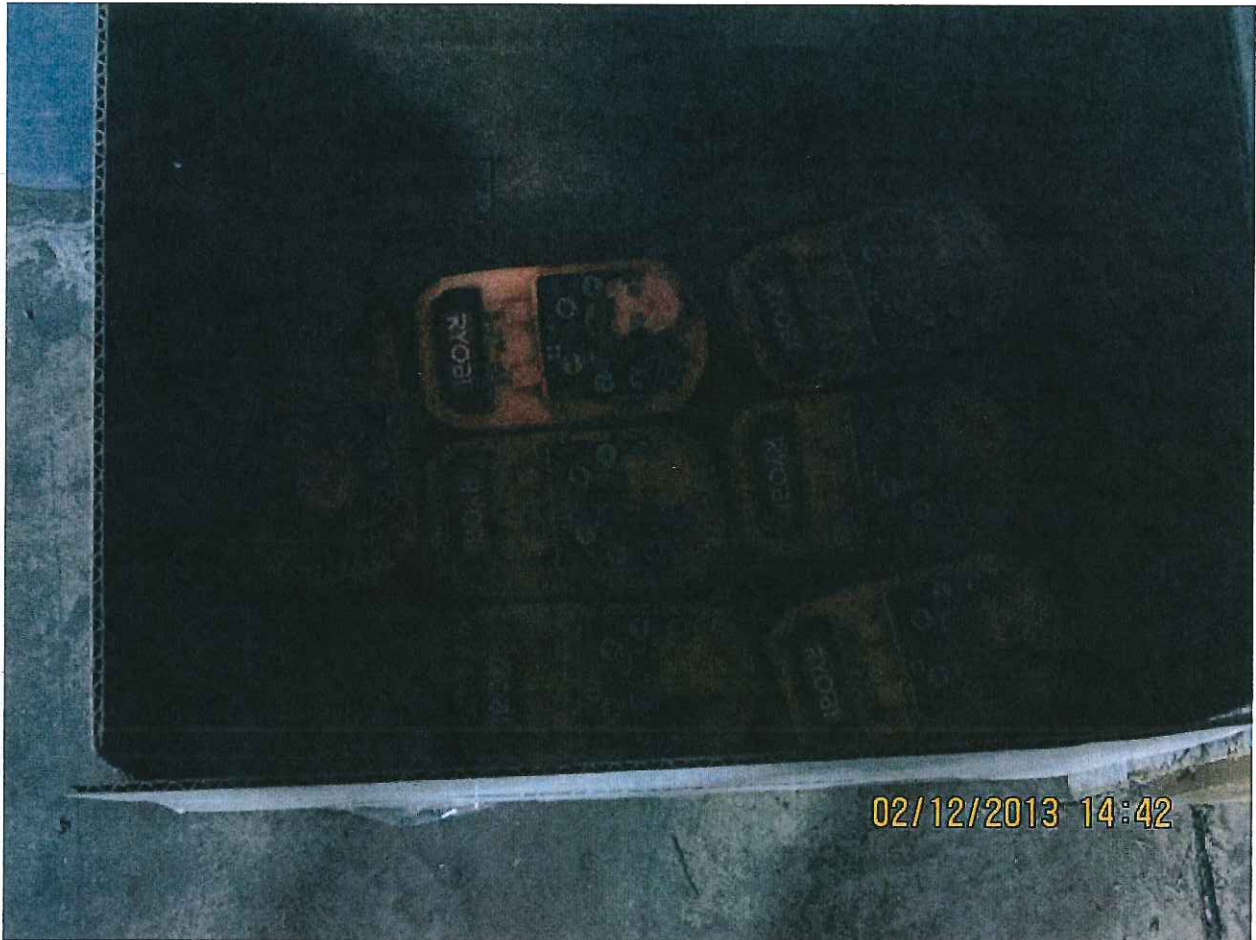
Photograph: #34

During the inspection of the Universal Waste Accumulation Area, the inspector observed batteries stored in a container that was not properly labeled and marked as universal waste. Multicircuits, therefore, violated the above-referenced universal waste requirements. However, Multicircuits, submitted documentation on April 8, 2013 showing the proper labeling and marking of the container storing the batteries. Thus, no further actions are necessary to comply with the above-reference condition/requirement.
